# ER-2 Test Flight 1 July 28

# ER-2 Science Flights for ORACLES (Aug-Sep 2016)

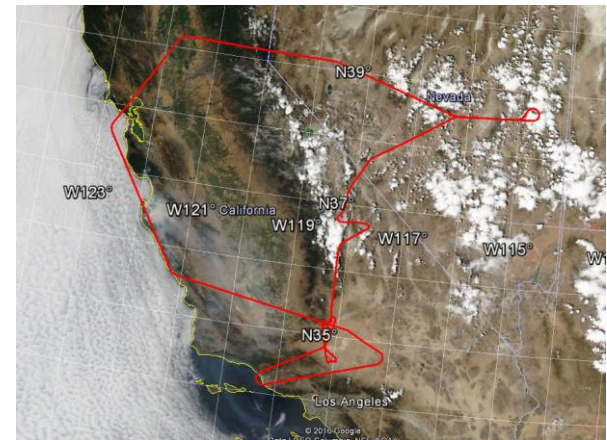
AirMSPI  
Sweep off  
Monterey Coast  
South

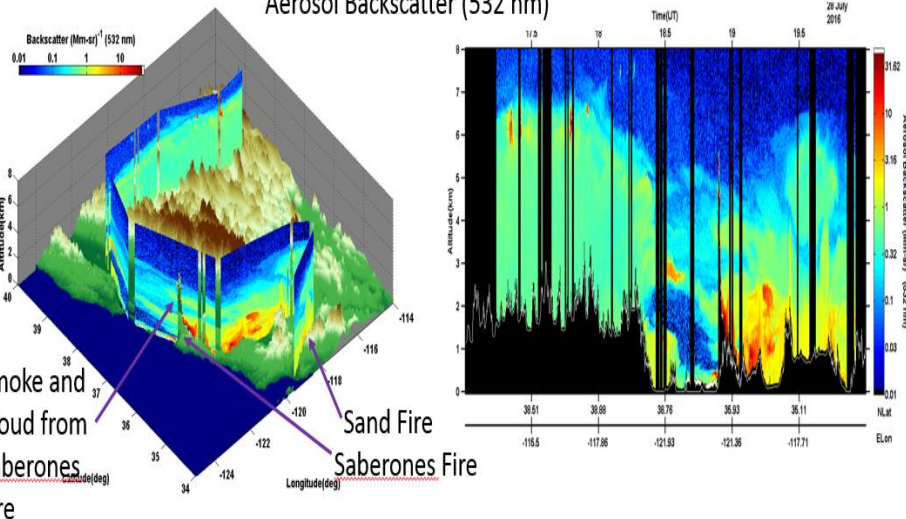
## HSRL-2

Aerosol Backscatter (532 nm)

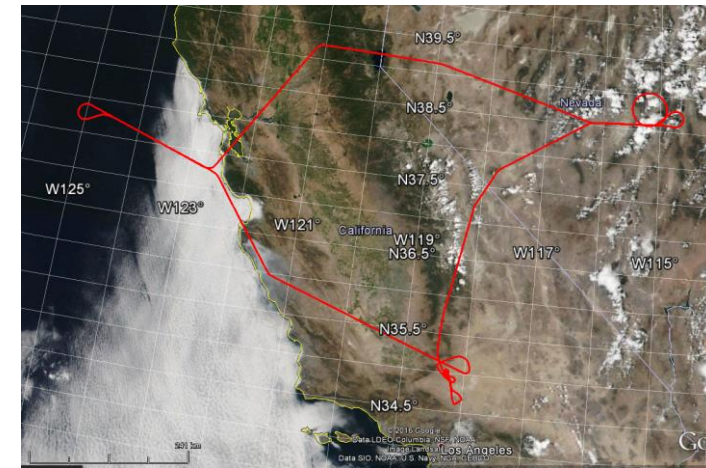
AirMSPI sweep over cloud and smoke from Soberanes fire

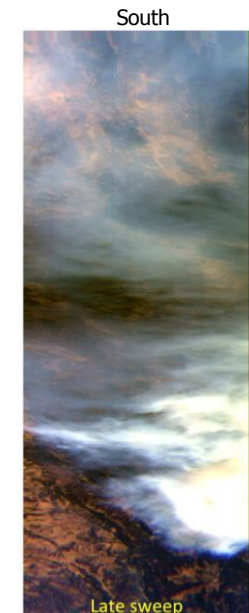
eMAS data over cloud and smoke from Soberanes fire

Flight Direction  
R: 2.13µm  
G: 1.61µm  
B: 0.55µm

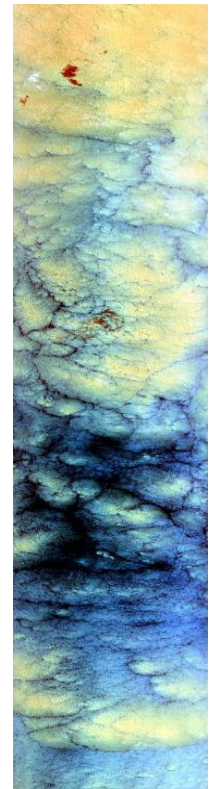
eMAS  
08:57-09:30 UT

- Varying displacement of elevated smoke layer above low clouds

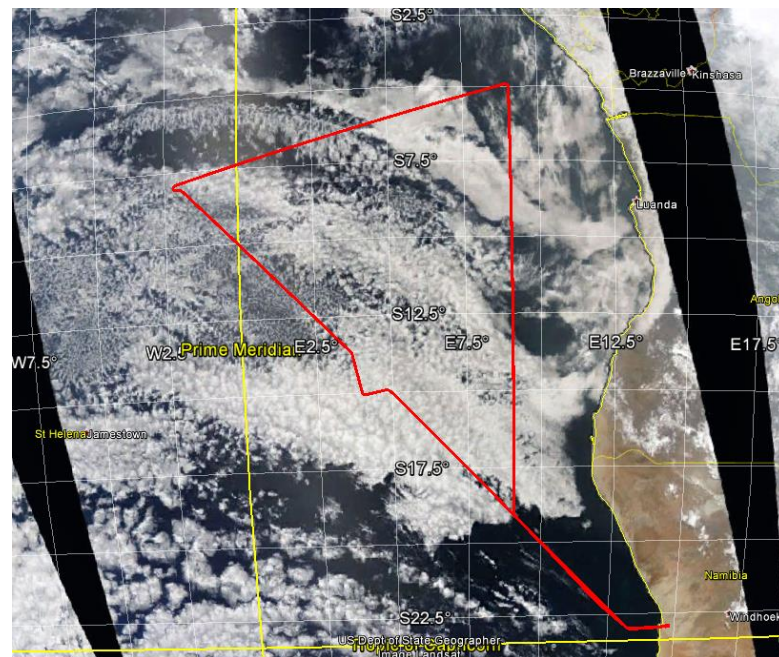
eMAS data  
along Aqua  
overpass

↓ ↓ ↓  
R: 0.47μm  
G: 1.61μm  
B: 2.13μm
